SUBJECT: FINAL ENVIRONMENTAL ASSESSMENT AND
FINDING OF NO SIGNIFICANT IMPACT FOR
KAMEHAMEHA V HIGHWAY, MAKAKUPAIA STREAM BRIDGE
REPLACEMENT, PROJECT NO. STP-0450(010)
DISTRICT OF MOLOKAI, ISLAND OF MOLOKAI
TAX MAP KEYS: (2) 5-4-003:28 por. and (2) 5-4-017:44 por.

Project Name:	Makakupaia Bridge Stream Replacement, Molokai, Hawaii, Project No. STP-0450(010)
Project Short Name:	Makakupaia Bridge Replacement
HRS §343-5 Trigger(s):	Use of state lands and funds
Island(s):	Molokai
Judicial District(s):	Kona District
TMK(s):	Highway right-of-way bordering TMK(2)5-4-017- various and 5-4-003- various
Permit(s)/Approval(s):	National Pollutant Discharge Elimination System (NPDES), State of Hawaii DBEDT-Coastal Zone Management Federal Consistency, State of Hawaii DLNR-Section 106 National Historic Preservation Act Compliance, State of Hawaii DOH Noise Permit/Variance, County of Maui-Special Management Area
Proposing/Determining Agency:	State of Hawaii Department of Transportation
Contact Name, Email, Telephone, Address	Justin Rush, justin.se.rush@hawaii.gov , 808-692-8427 State of Hawaii, Department of Transportation, 601 Kamokila Boulevard, Room 609, Kapolei, HI 96707

Makakupaia Bridge Repl

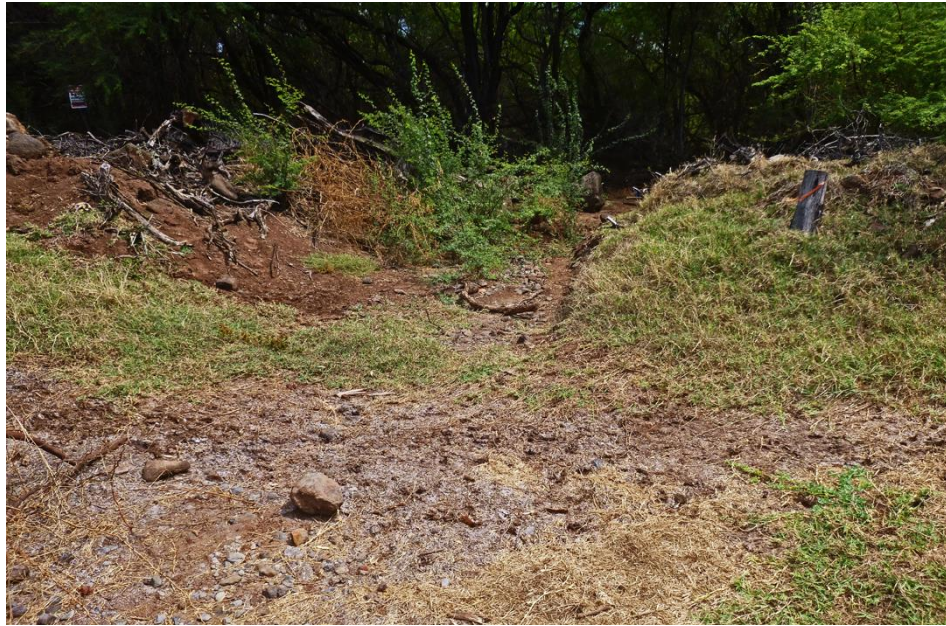
Figure 8. Excavated channel upstream of bridge.

A channel directs flow from the *kiawe* forest under Kamehameha V Highway Bridge. This channel appears to have been recently excavated (Figure 8) and has neither a bed and banks, nor an ordinary high water mark (OHWM). However, 100 m (330 ft) upstream of the highway, well outside of the Project area, Makakupa'ia Gulch contains a bed and banks and OHWM. Due to the proximity of the gulch to the jurisdictional *muliwai* and Pacific Ocean, the conservative approach is to consider the entire stream channel within the Project Area to be jurisdictional.

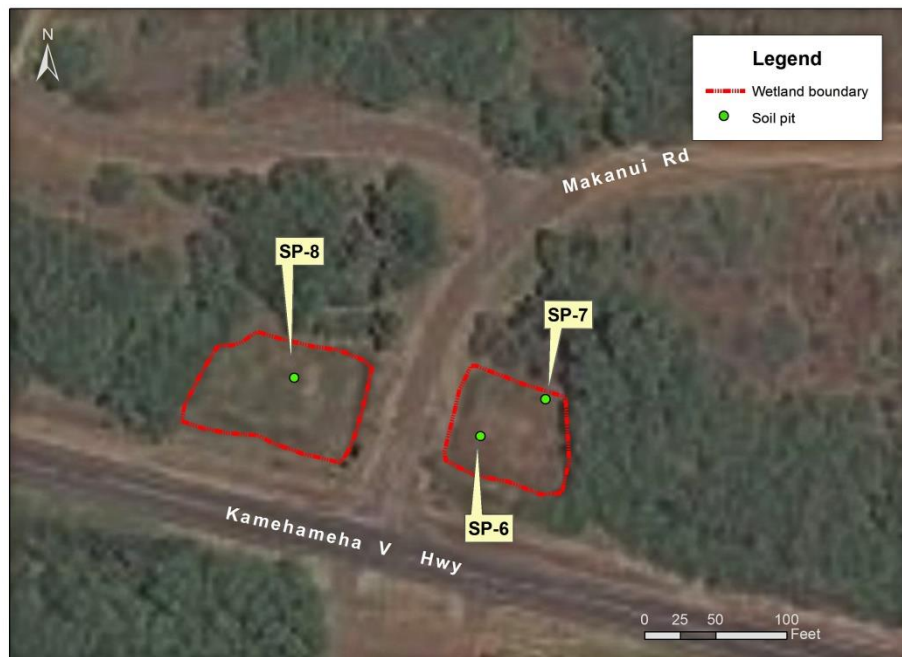
Figure 9. Retention basin wetland boundaries as determined on April 8, 2016.

We completed three wetland data determination forms in the potential staging area and determined the two basins are wetlands. Wetland boundaries of the basins are shown in Figure 9). Due to their proximity to the shore (approximately 60 m or 200 ft), these wetlands are likely to be considered to be adjacent wetlands and, therefore, jurisdictional under the CWA.

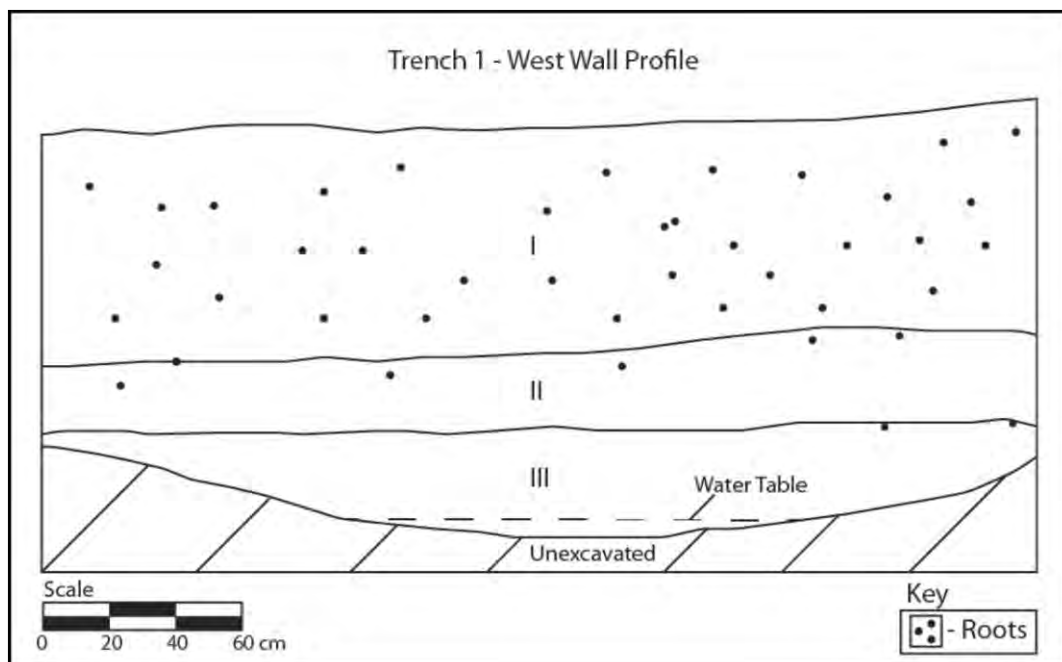
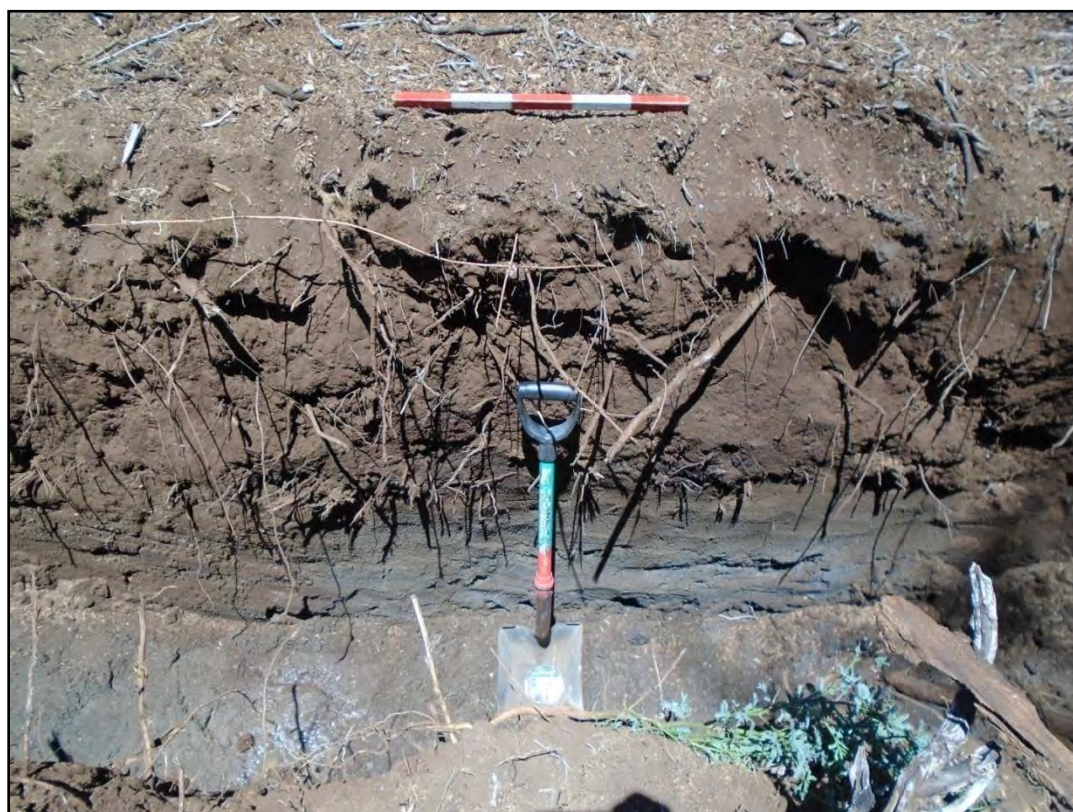
I	0-70 cmbs	Very dusky red (2.5YR 2.5/2) loam; moderate, fine, crumb; very friable, slightly sticky, slightly plastic; abrupt, smooth boundary. Modern trash debris on surface. Roots throughout layer. Natural.
II	62-98 cmbs	Very dark brown (10YR 2/2) loamy sand; weak, fine, granular; very friable, nonsticky, nonplastic; abrupt, smooth boundary. No cultural material observed. Natural.
III	90-124 cmbs	Dark brown (7.5YR 3/2) loamy sand; weak, fine, granular; very friable, nonsticky, nonplastic. Water table encountered at 120 cmbs. No cultural material observed; natural. The color of this layer in Figure 10 makes this deposit look gleyed, it is possible a portion of the Layer III is partially gleyed due to a fluctuating intertidal water level in this area.

Figure 9. Trench 1, West Wall Profile.

Figure 10. Trench 1, West Wall Profile (view west; scale bar = 50 cm long).

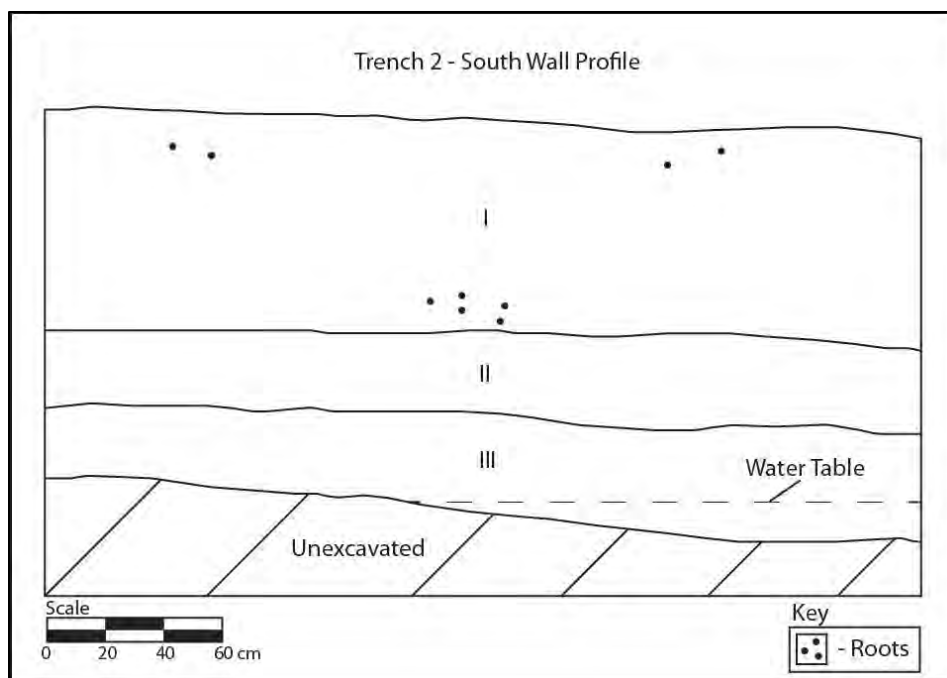
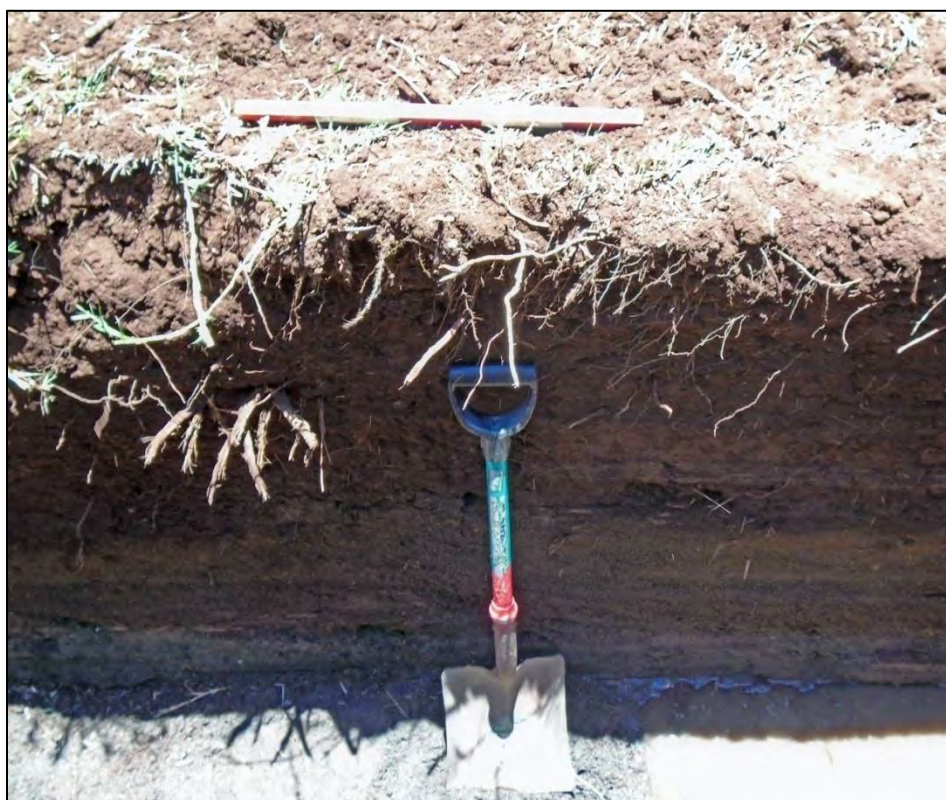
I	0-76 cmbs	Very dusky red (2.5YR 2.5/2) loam; moderate, fine, crumb; very friable, slightly sticky, slightly plastic; abrupt, smooth boundary. Contained roots. No cultural material observed. Natural.
II	72-102 cmbs	Very dark brown (10YR 2/2) loamy sand; weak, fine, granular; very friable, nonsticky, nonplastic; abrupt, smooth boundary. No cultural material observed. Natural.
III	100-142 cmbs	Dark Brown (7.5YR 3/2) Loamy Sand; weak, fine, granular; very friable, nonsticky, nonplastic. Water table encountered at 129 cmbs. No cultural material observed. Natural.

Figure 11. Trench 2, South Wall Profile.

Figure 12. Trench 2, South Wall Profile (view south; scale bar = 50 cm long).

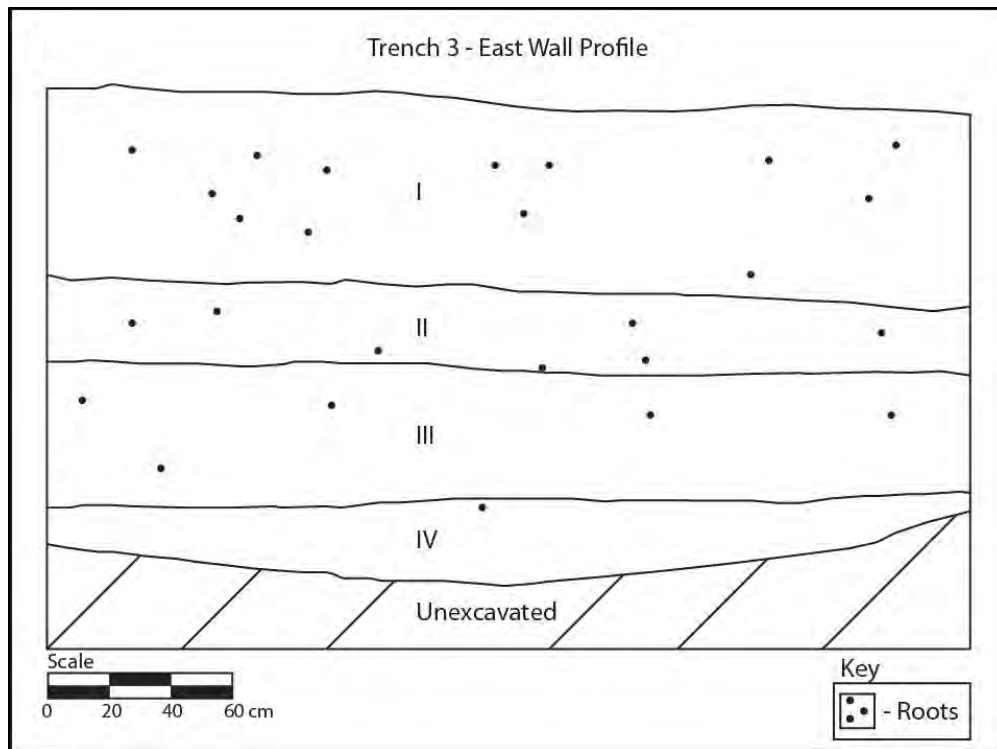
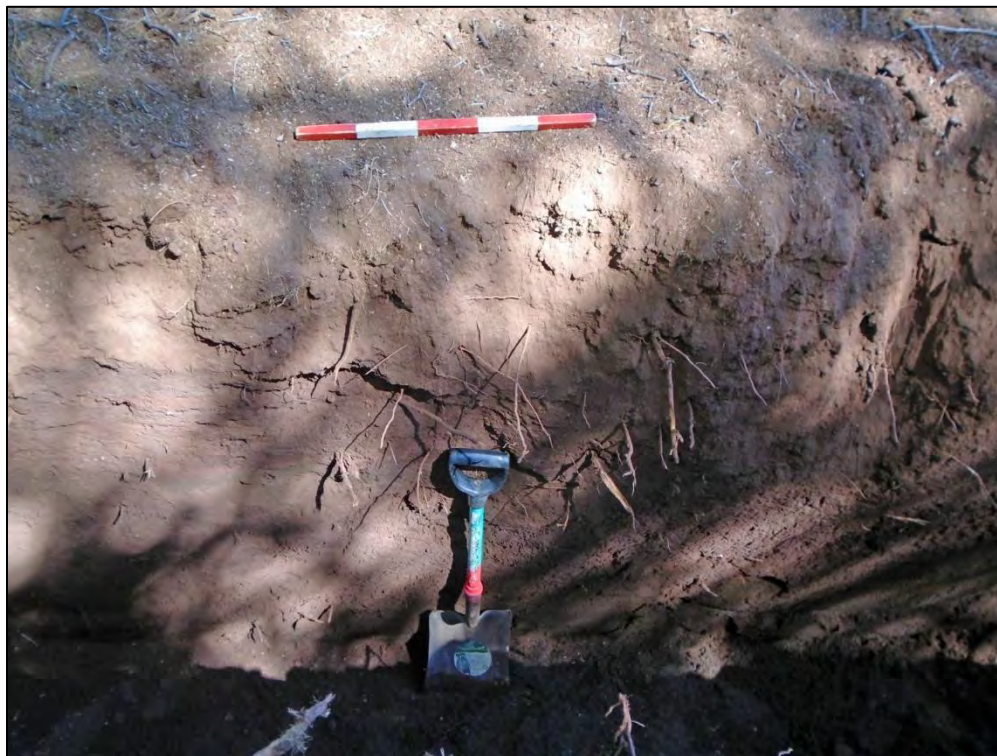
I	0-65 cmbs	Very dusky red (2.5YR 2.5/2) loam; moderate, fine, crumb; very friable, slightly sticky, slightly plastic; abrupt, smooth boundary. Contained roots. No cultural material observed. Natural.
II	59-90 cmbs	Very dark brown (7.5 YR 2.5/2) clay loam; moderate, medium, crumb; very friable, slightly sticky, plastic; abrupt, smooth boundary. Contained roots. No cultural material observed. Natural.
III	84-136 cmbs	Dark reddish brown (2.5YR 3/3) sandy clay loam; weak, fine, granular; very friable, slightly sticky, slightly plastic; abrupt, smooth boundary. Contained roots. No cultural material observed. Natural.
IV	122-159 cmbs	Dark reddish brown (5YR 2.5/2) loamy sand; weak, fine, granular; very friable, nonsticky, nonplastic. No cultural material observed. Natural.

Figure 13. Trench 3, East Wall Profile.

Figure 14. Trench 3, East Wall Profile (view east; scale bar = 50 cm long).

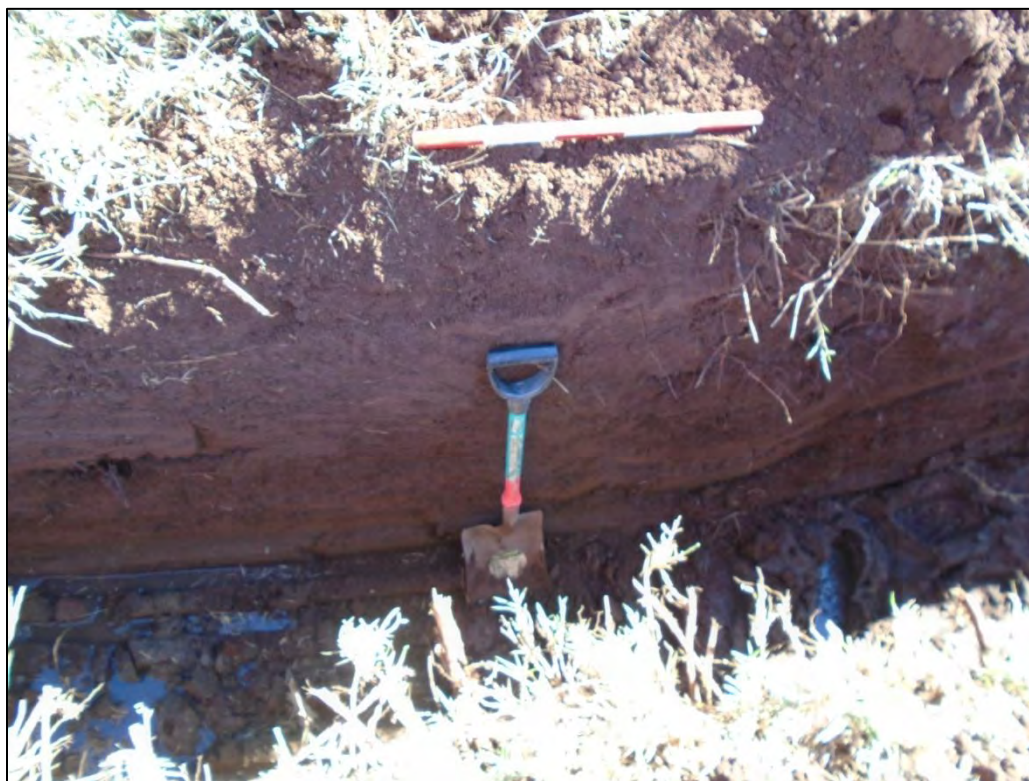
I	0-78 cmbs	Dark reddish brown (5YR 2.5/2) clay loam; moderate, medium, crumb; very friable, sticky, plastic; abrupt, smooth boundary. Contained roots. No cultural material observed. Natural.
II	68-118 cmbs	Very dark brown (7.5YR 2.5/2) clay loam; moderate, medium, angular blocky; very friable, very sticky, very plastic; abrupt, smooth boundary. Contained a single basalt cobble. No cultural material observed. Natural.
III	108-137 cmbs	Very dark brown (10YR 2/2) clay loam; moderate, medium, angular blocky; very friable, very sticky, very plastic. Water table encountered at 132 cmbs. No cultural material observed. Natural.

Figure 15. Trench 4, North Wall Profile.

Figure 16. Trench 4, North Wall Profile (view north; scale bar = 50 cm long).

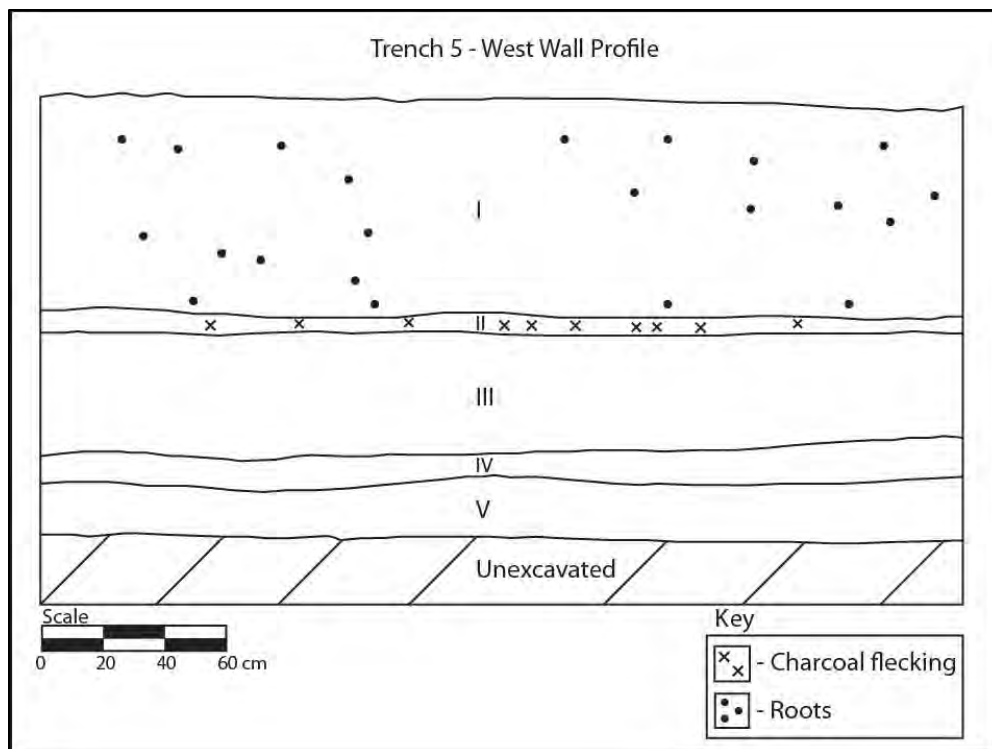
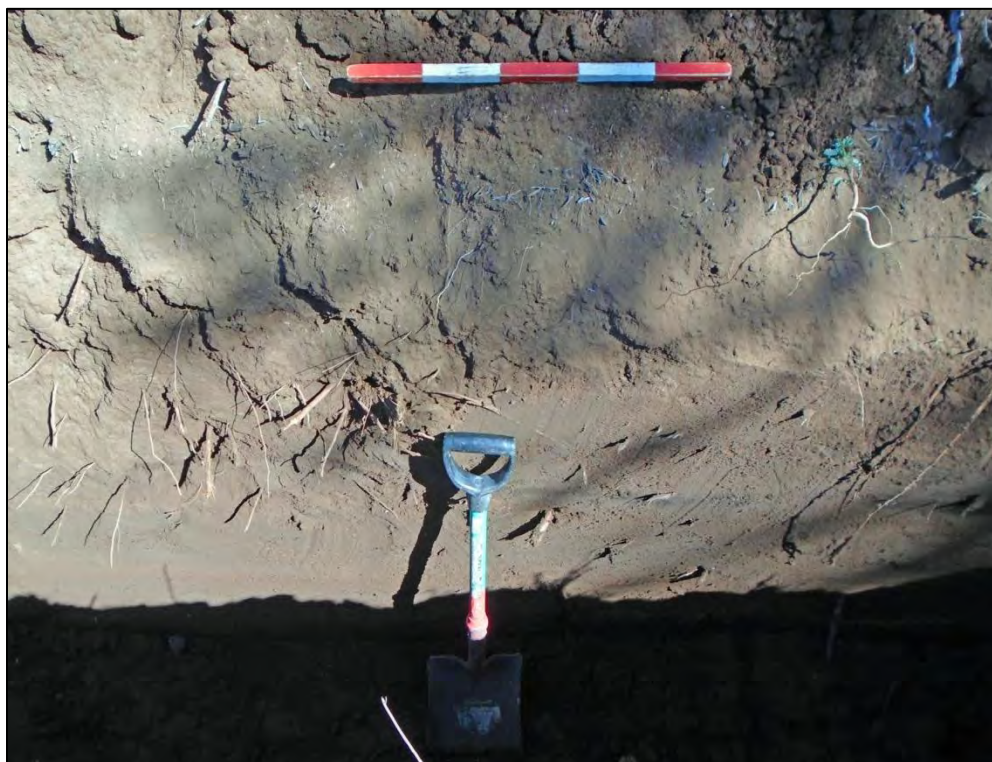
I	0-70 cmbs	Very dusky red (2.5YR 2.5/2) loam; moderate, fine, crumb; very friable, slightly sticky, slightly plastic; abrupt, smooth boundary. Contained roots. No cultural material observed. Natural.
II	68-77 cmbs	Black (5YR 2.5/1) clay loam; moderate, medium, crumb; very friable, sticky, plastic; abrupt, smooth boundary. Contained charcoal flecking. No cultural material observed. Natural.
III	75-118 cmbs	Very dark brown (7.5YR 2.5/2) clay; moderate, medium, angular blocky; very friable, sticky, plastic; abrupt, smooth boundary. No cultural material observed. Natural.
IV	108-128 cmbs	Dark reddish brown (5YR 3/3) clay loam; moderate, medium, crumb; very friable, sticky, plastic; abrupt, smooth boundary. No cultural material observed. Natural.
V	121-142 cmbs	Dark reddish brown (5YR 2.5/2) sandy loam; weak, fine, granular; very friable, nonsticky, nonplastic. No cultural material observed. Natural.

Figure 17. Trench 5, West Wall Profile.

Figure 18. Trench 5, West Wall Profile (view west; scale bar = 50 cm long).

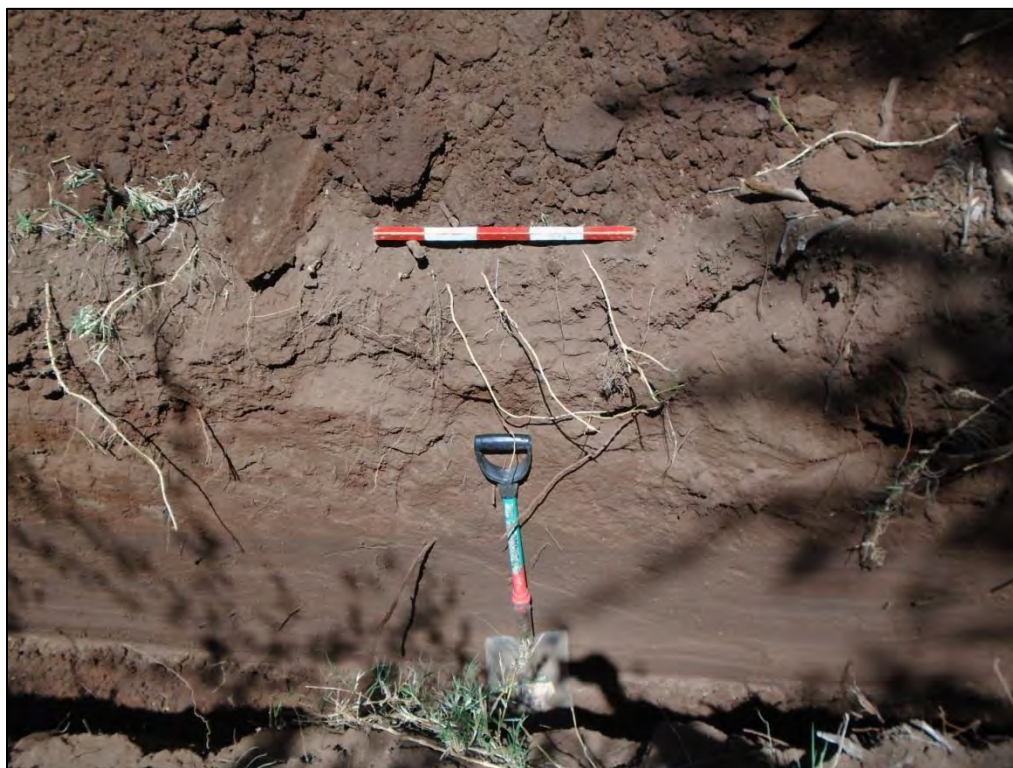
I	0-90 cmbs	Very dusky red (2.5YR 2.5/2) loam; moderate, fine, crumb; very friable, slightly sticky, slightly plastic; abrupt, smooth boundary. Partially mottled. Contained roots. No cultural material observed. Natural.
II	84-128 cmbs	Dark reddish brown (5YR 2.5/2) clay loam; moderate, medium, angular blocky; friable, slightly sticky, plastic; abrupt, smooth boundary. No cultural material observed. Natural.
III	125-146 cmbs	Dark reddish brown (5YR 3/3) clay; moderate, medium, angular blocky; very friable, very sticky, very plastic. Partially mottled. No cultural material observed. Natural.

Figure 19. Trench 6, West Wall Profile.

Figure 20. Trench 6, West Wall Profile (view west; scale bar = 50 cm long).

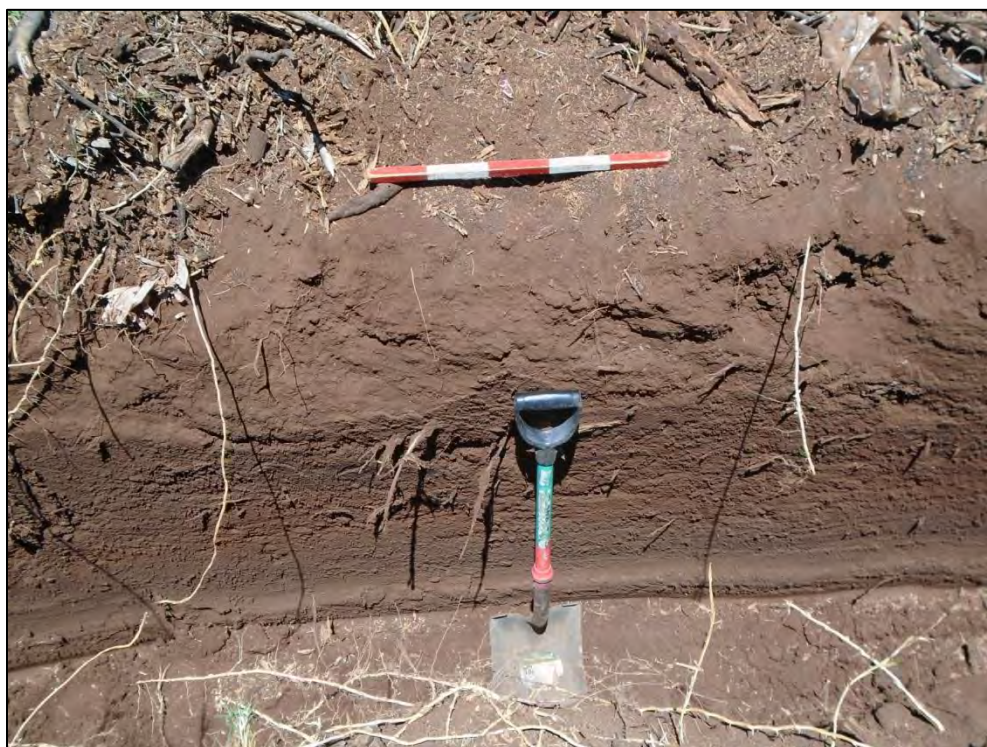
I	0-58 cmbs	Very dusky red (2.5YR 2.5/2) loam; moderate, fine, crumb; very friable, slightly sticky, slightly plastic; abrupt, smooth boundary. Contained roots. No cultural material observed. Natural.
II	50-65 cmbs	Black (5YR 2.5/1) clay loam; moderate, medium, crumb; very friable, sticky, plastic; abrupt, smooth boundary. Contained charcoal flecking. No cultural material observed. Natural.
III	57-97 cmbs	Dark reddish brown (5YR 3/3) clay loam; weak, medium, crumb; very friable, slightly sticky, plastic; abrupt, smooth boundary. No cultural material observed. Natural.
IV	90-120 cmbs	Dark reddish brown (5YR 3/3) clay; moderate, medium, angular blocky; very friable, very sticky, very plastic; abrupt, smooth boundary. No cultural material observed. Natural.
V	114-142 cmbs	Dark reddish brown (5YR 2.5/2) clay loam; moderate, fine, crumb; very friable, nonsticky, slightly plastic. No cultural material observed. Natural.

Figure 21. Trench 7, West Wall Profile.

Figure 22. Trench 7, West Wall Profile (view west; scale bar = 50 cm long).

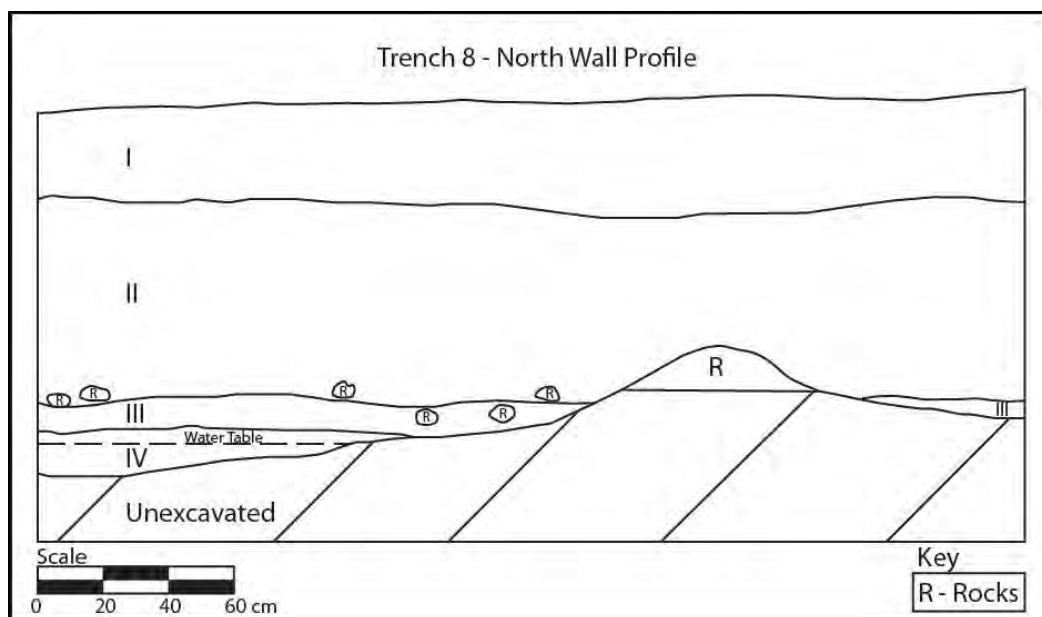
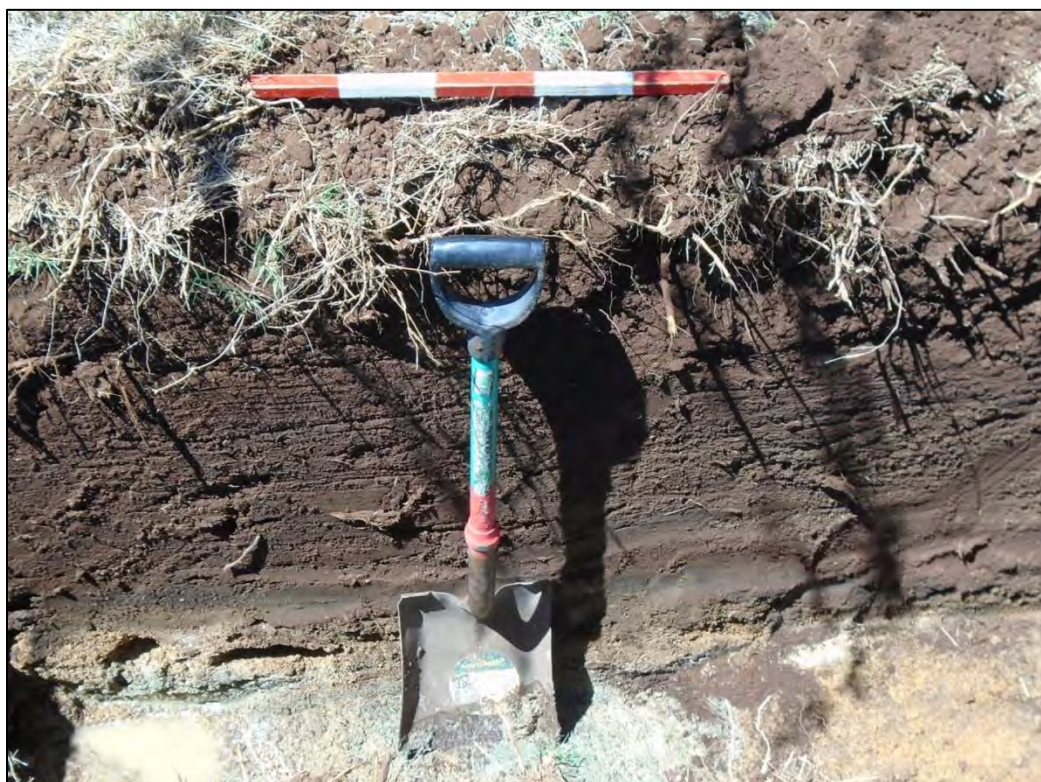
I	0-36 cmbs	Very dusky red (2.5YR 2.5/2) loam; moderate, fine, crumb; very friable, slightly sticky, slightly plastic; abrupt, smooth boundary. No cultural material observed. Natural.
II	25-94 cmbs	Dark reddish brown (5YR 3/3) clay loam; moderate, medium, angular blocky; very friable, slightly sticky, plastic; abrupt, smooth boundary. Contained basalt cobbles near base of layer. No cultural material observed. Natural.
III	88-99 cmbs	Yellowish brown (10YR 5/4) sand; structureless; medium, single grain; loose, noncoherent, nonsticky, nonplastic; abrupt, smooth boundary. Contained basalt cobbles near top of layer. No cultural material observed; natural. The color of this layer in Figure 24 makes this deposit look gleyed, it is possible a portion of the Layer III is partially gleyed due to a fluctuating intertidal water level in this area.
IV	96-109 cmbs	Brown (10YR 5/3) loamy sand; weak, fine, granular; very friable, nonsticky, nonplastic. Water table encountered at 102 cmbs. No cultural material observed. Natural.

Figure 23. Trench 8, North Wall Profile.

Figure 24. Trench 8, North Wall Profile (view north; scale bar = 50 cm long).

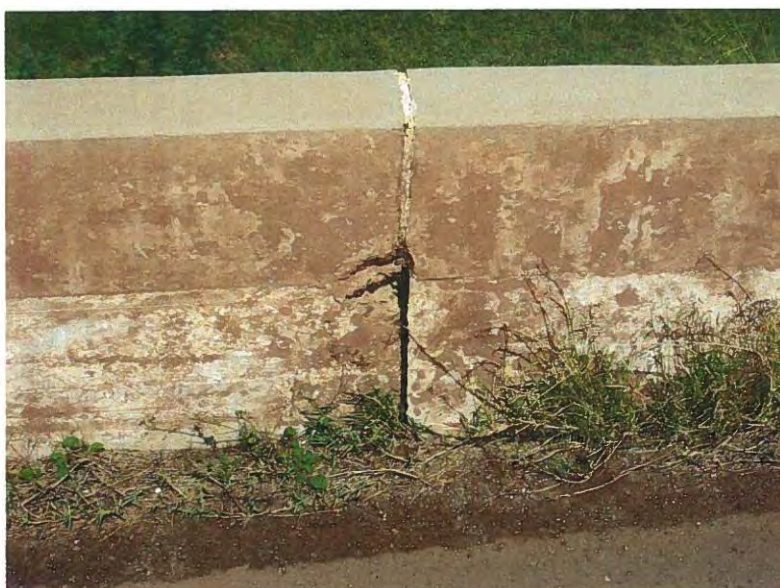
PHOTO 6 SPALL IN UPSTREAM PARAPET NEAR OUTBOUND END

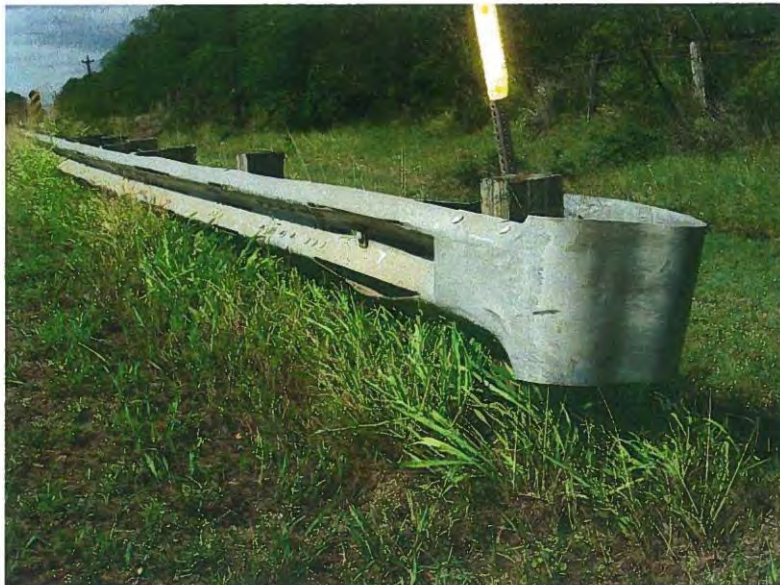
PHOTO 7 COLLISION DAMAGE IN UPSTREAM OUTBOUND APPROACH GUARDRAIL END

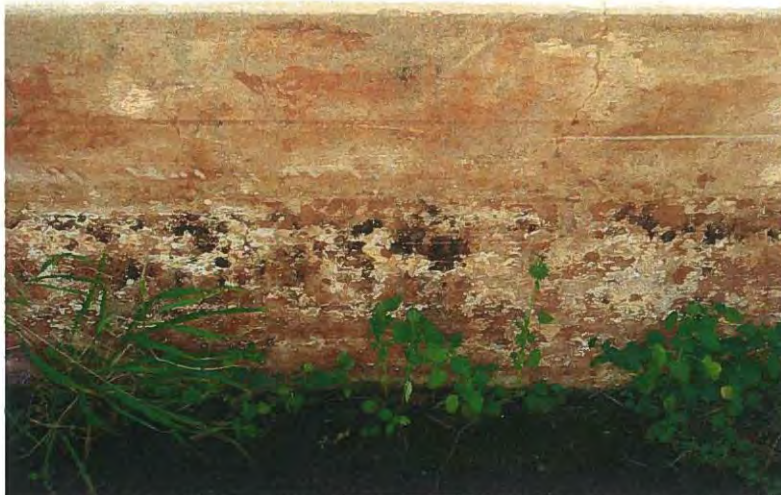
PHOTO 10 TYPICAL HAIRLINE CRACK IN DOWNSTREAM BRIDGE PARAPET

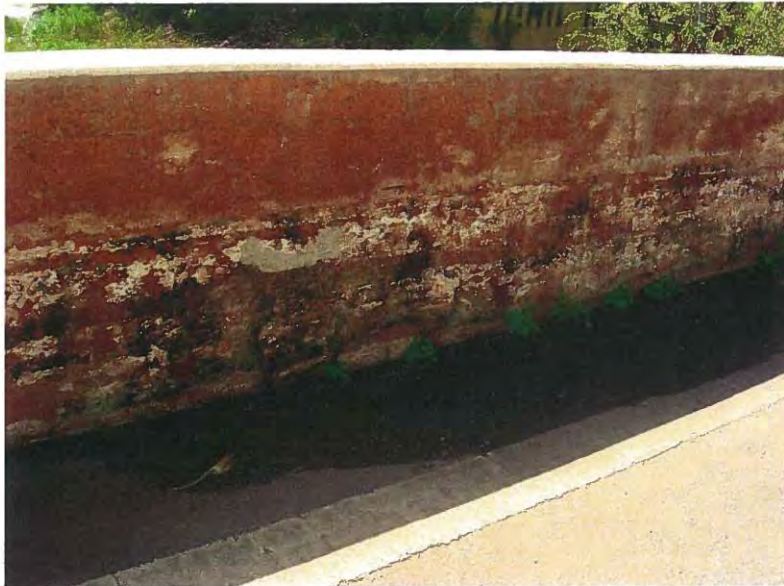
PHOTO 11 SPALLS AND DELAMINATIONS ALONG BASE OF DOWNSTREAM BRIDGE PARAPET

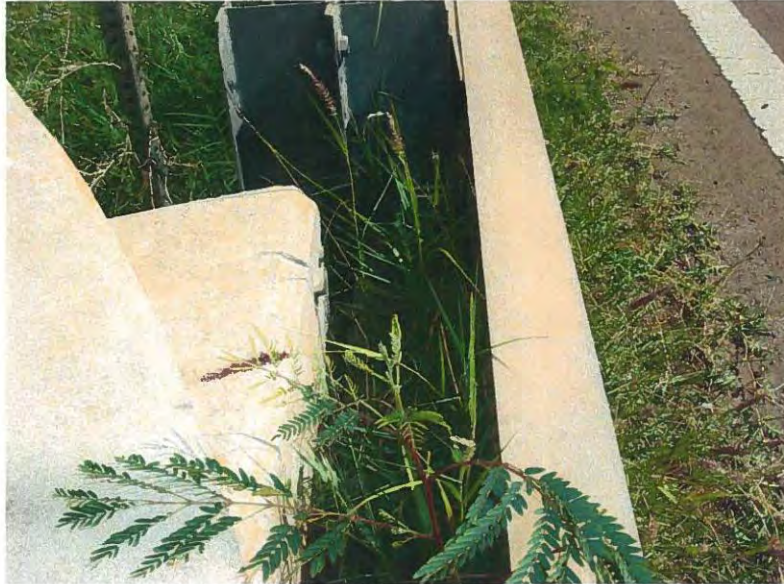
PHOTO 13 MISSING SPACER BLOCK BETWEEN BRIDGE PARAPET ENDWALL AND GUARDRAIL

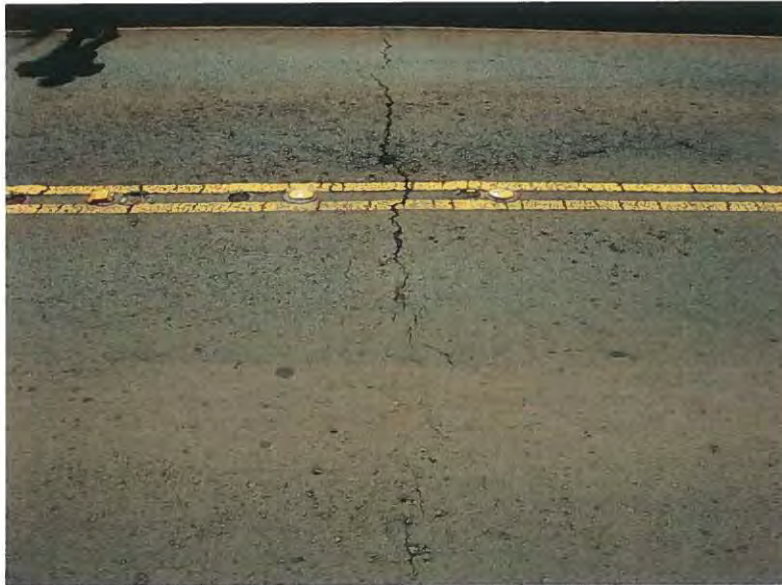
PHOTO 15 TRANSVERSE CRACK IN AC PAVEMENT OVER OUTBOUND ABUTMENT

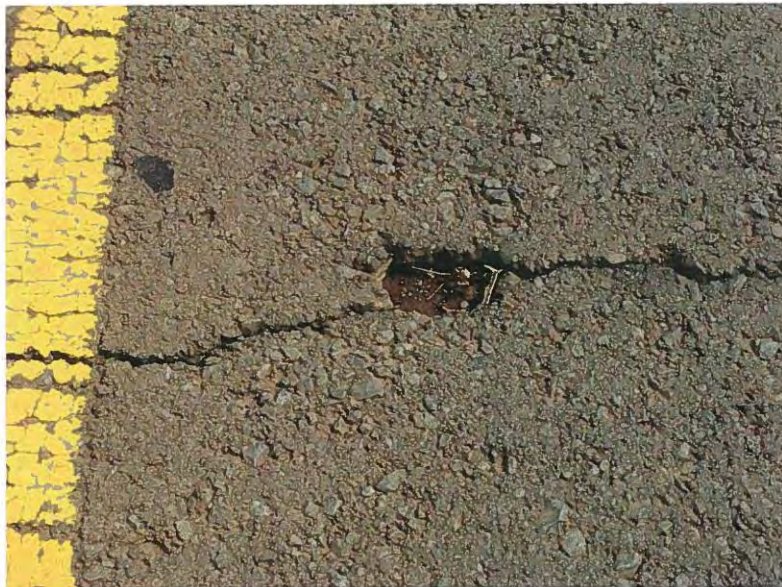
PHOTO 16 CLOSE UP VIEW OF TRANSVERSE CRACK IN AC PAVEMENT OVER OUTBOUND ABUTMENT AND POTHOLE

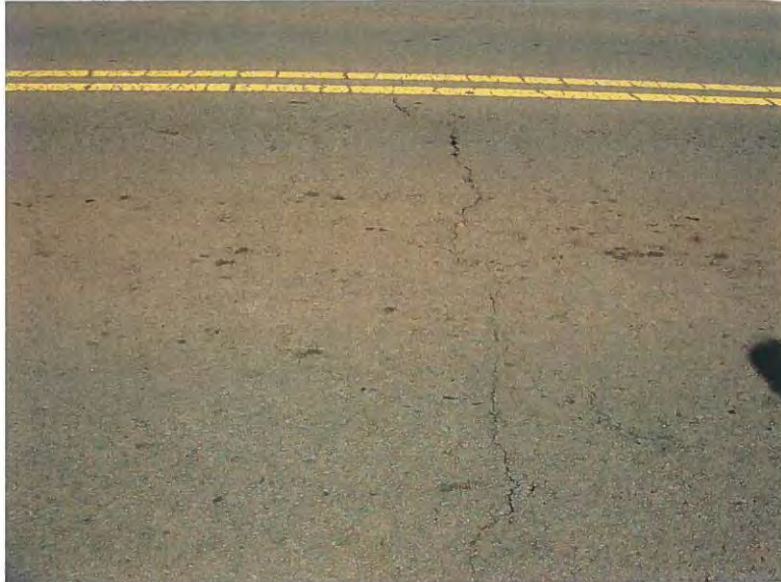
PHOTO 17 TRANSVERSE CRACK IN AC PAVEMENT OVER INBOUND ABUTMENT

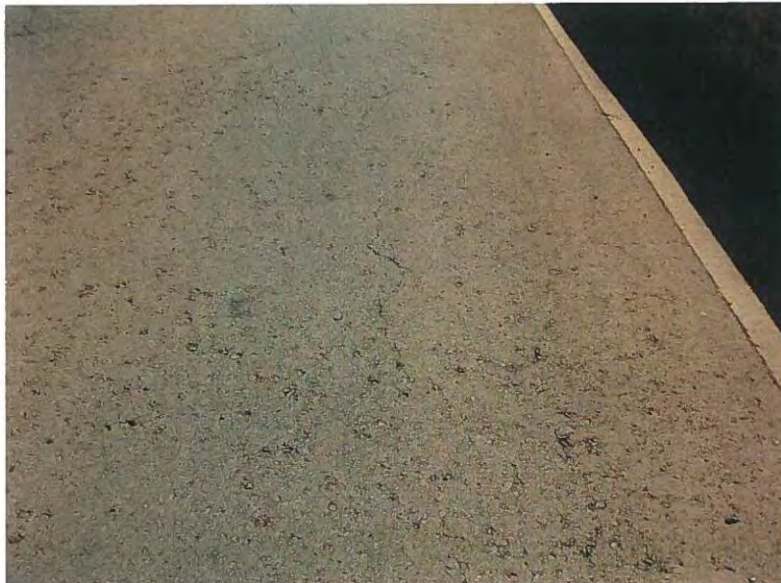
PHOTO 18 LONGITUDINAL CRACK IN AC PAVEMENT

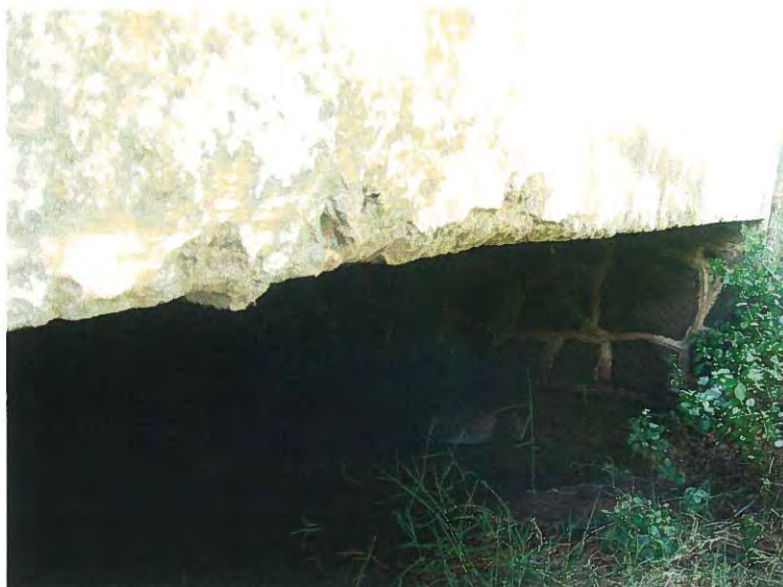
PHOTO 22 SPALLS ALONG UPSTREAM SOFFIT EDGE
